**REPORT OF VISIT TO  
BENGKULU EARTHQUAKE STRICKEN AREA  
10 – 13 JUNE 2000**

**INDONESIAN URBAN DISASTER MITIGATION PROJECT  
INSTITUTE FOR RESEARCH-INSTITUT TEKNOLOGI BANDUNG  
ASIAN DISASTER PREPAREDNESS CENTER**

## **VISIT REPORT TO BENGKULU EARTHQUAKE STRIKEN AREA (4<sup>TH</sup> JUNE 2000)**

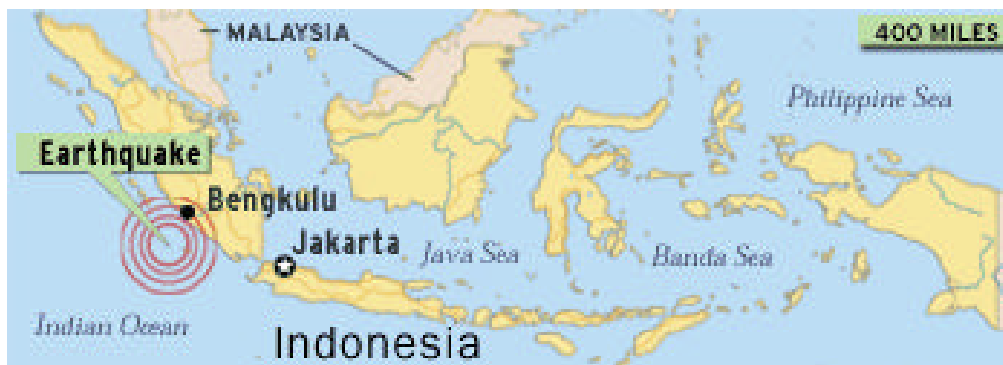
The earthquake was recorded by BMG (Bureau of Meteorology and Geophysics, Jakarta), besides the USGS, Harvard and ERI networks. Location of epicenter is approximately  $4.73^{\circ}$  S -  $102^{\circ}$  E at the depth of 33 km (BMG), and it was the biggest earthquake in 80 years recorded in the region. The seismic mechanism is reported as reverse fault (USGS) or strike-slip (ERI).

Figure 1 Location of Bengkulu earthquake epicenter

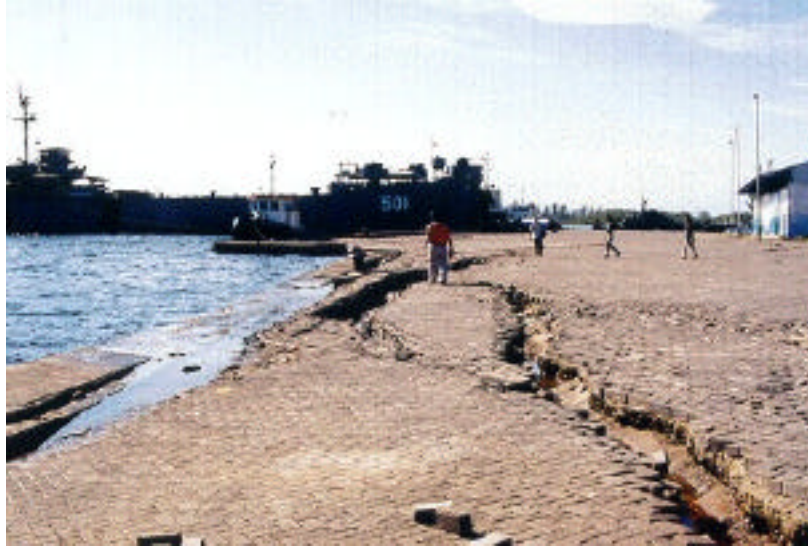
- ❑ Airport  
Airport Padang Kemiling is the only air gate to the province., During the earthquake, the control tower and the terminal buildings have suffered some non structural damages, while the runway and apron are still intact. The airport is operated on VFR and on the 7<sup>th</sup> of June, it can be operated again and relief material and personnel can be transported by air.
- ❑ Harbor  
The Padang Baai Harbor suffered some damages on its jetty, but it can still operate. The only problem is in the main access road, where a major bridge connecting the access road to the City of Bengkulu has suffered major damage on its approaches, but it was soon restored to operation by the 7<sup>th</sup> of June by putting new embankment on its approaches. Relief material can be transported again from this port.

Figure 2 Damage at Pulau Baai harbor

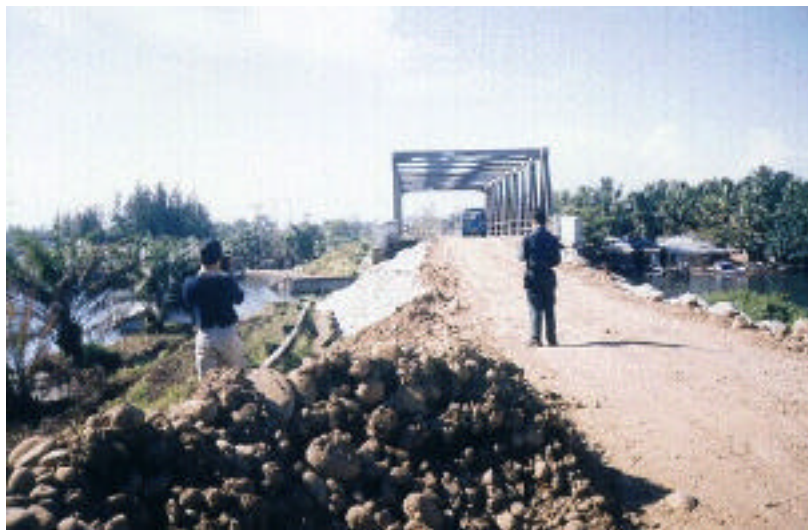
Land transportation was disrupted slightly by damages in 56 location and damaged bridges (light and heavy) recorded in 17 bridges location, almost all have been operating normally when the visit was carried out.

Figure 3 Bridge near the Pulau Baai harbor after temporary rehabilitation

The Public Works Department has mobilized emergency response team to clear landslide which blocked the main provincial road to the south of Bengkulu and restoring damaged bridge on the main harbor road by putting new embankments, constructing emergency sanitation in the damaged main hospital, assessing damaged buildings for re-occupation possibility and other emergency construction works.

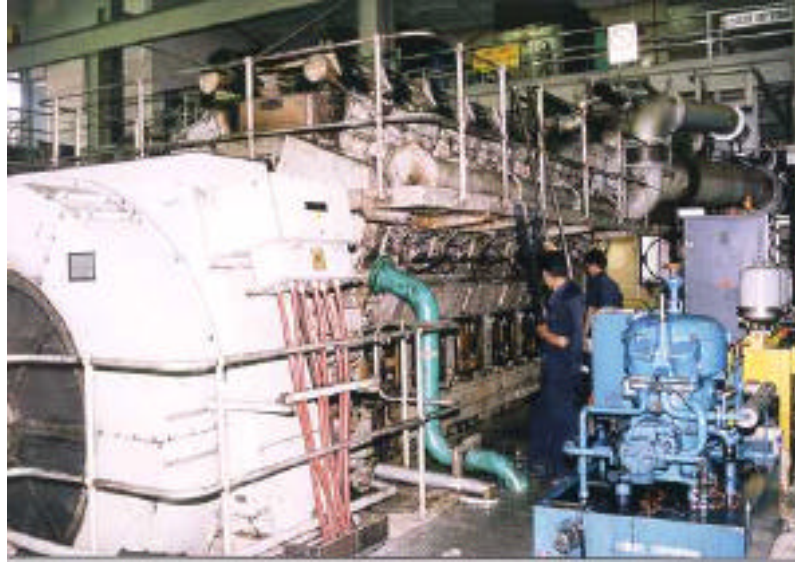
Power line has been reestablished within 3 days of the main shock. Some damages were observed at the power plant (shifted engine foundation).

Figure 4 The generator No. 2 at PLTD Suko Merindu is under repair after the earthquake

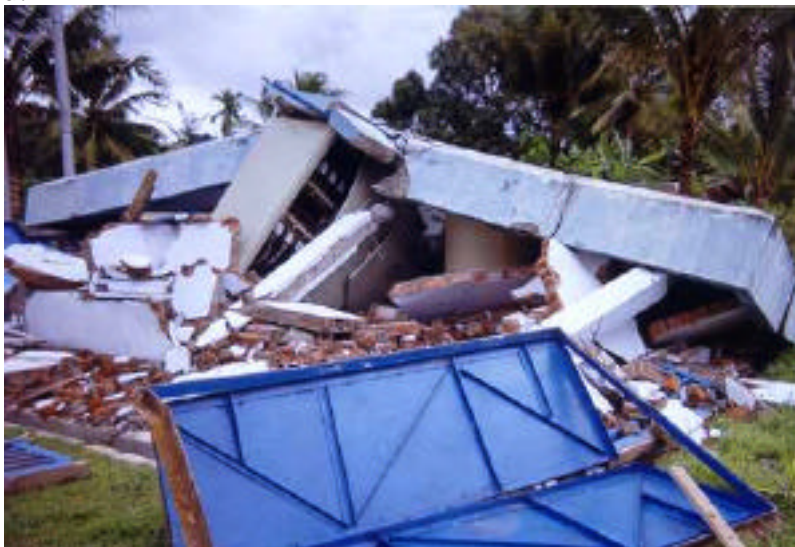
Water supply system in the city suffered from damages in the powerhouse and chemical mixing building and some damages (about 1000 meters) of transmission and distribution lines including a 12 m pipe bridge. Two small sub-district water treatment plants (IKK Talang Alai and IKK Suka Raja in South Bengkulu district) suffered heavy damages. At the time of the team visit, piped water distribution in some places in Bengkulu City was not yet recovered.

Figure 5 Damaged powerhouse in water treatment plant in Bengkulu City

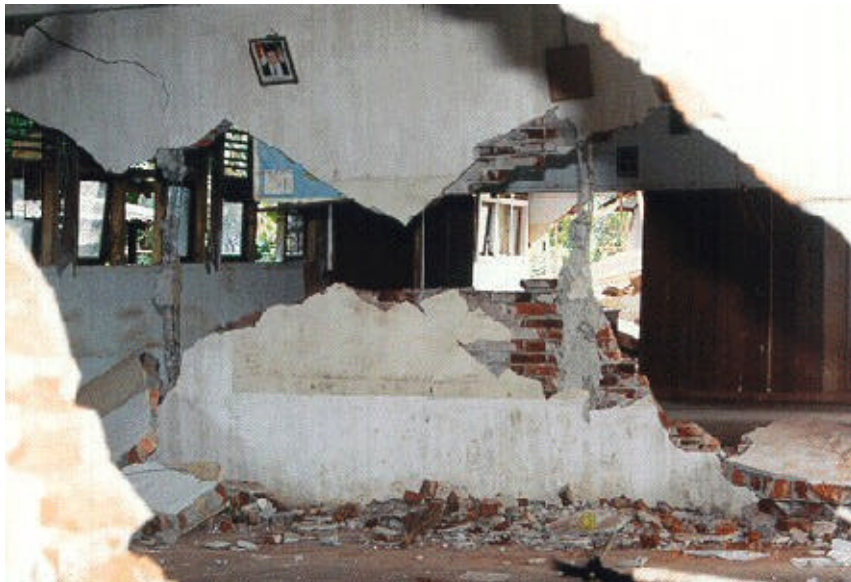
Damages were recorded in 639 elementary/primary schools, 36 junior secondary schools and 36 senior secondary schools. Besides, 3 university level institutions were also recorded as damaged. Damage varies from total collapse, heavy damage and light damage. However, only a few cases were found to be totally collapsed, in particular public primary schools built with INPRES fund.

Figure 7 Damaged school in Bengkulu City

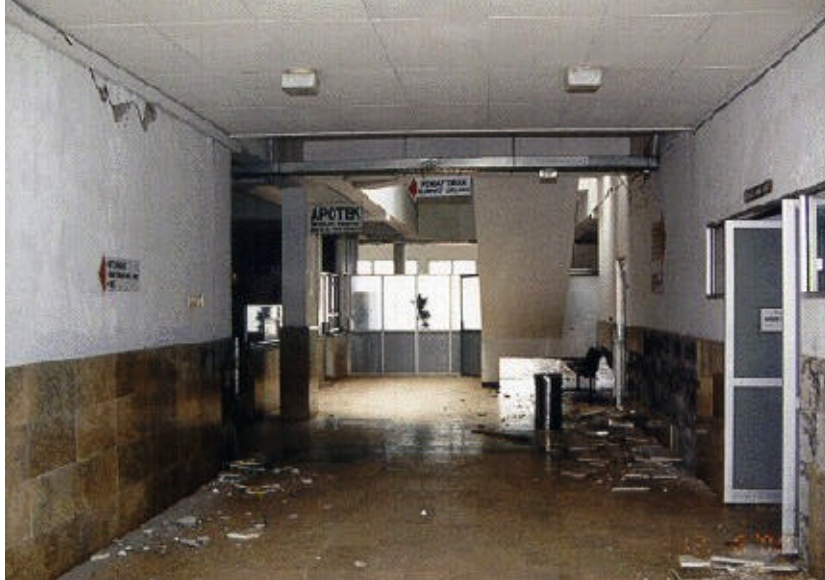
324 government offices and public facility buildings were affected. However, most of the damages are of the non-structural types, and many buildings can be quickly used again after proper fixing. Some buildings would need structural retrofit before use again.

Figure 8 Damaged general hospital in Bengkulu City

- Etc.)
- ❑ Inspect and retrofit prioritized critical facility buildings: hospitals, police stations, fire stations, main airport facility, telecommunication switching center, water treatment plant, power plant, both for structural and non-structural elements.

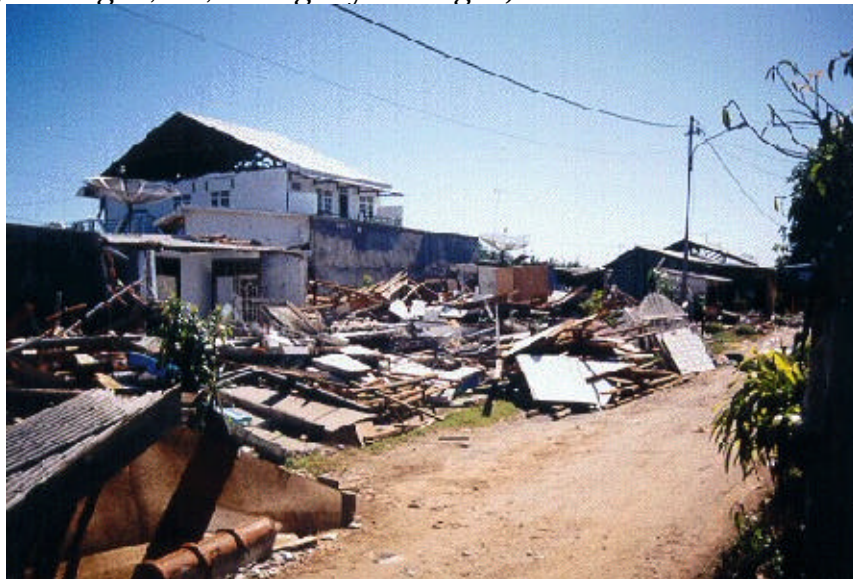
42,342 houses were reported as affected (1,386 total damage, 15,512 heavily damaged, 25,424 lightly damaged)

Figure 9 Example of residential damage in Bengkulu City

From general observation, it can be seen that most of the collapsed or heavily damaged buildings and houses were the non-engineered, masonry constructions, with or without reinforced concrete frame, in particular those built by low-income community or low-cost housing. In most cases non-structural damages were observed (cracked walls, collapsed interior ceilings, falling roof tiles, falling fixed furniture and equipment etc.). Cases of structural damage mostly due to improper detailing in the reinforcement (beam and column connection), improper concreting and inadequate steel stirrup/reinforcement and also from soft story effect on first floor columns.

Some liquefaction phenomenons were also observed, causing building subsidence. In many cases, collapsed structures in low-cost residential areas were caused by inadequate foundation built on poor soil condition (improper fill over swamp area or solid waste dump area).

All lifelines have to be prepared to face against seismic risk, with enough redundancies (case of harbor access road). Low-income people have to learn how to construct their houses safely using local material, using low cost seismic resistant building technology.
