Report on Post Earthquake Rapid Assessment Northern Pakistan – 8 October 2005

Mr. N.M.S.I. Arambepola
Urban Disaster Risk Management (UDRM)
Asian Disaster Preparedness Center (ADPC)
P.O. Box 4, Klong Luang, Pathumthani 12120, Thailand
Tel: (66-2) 524-5354 Fax: (66-2) 516-5900
Email: arambepola@adpc.net
www.adpc.net

Preface

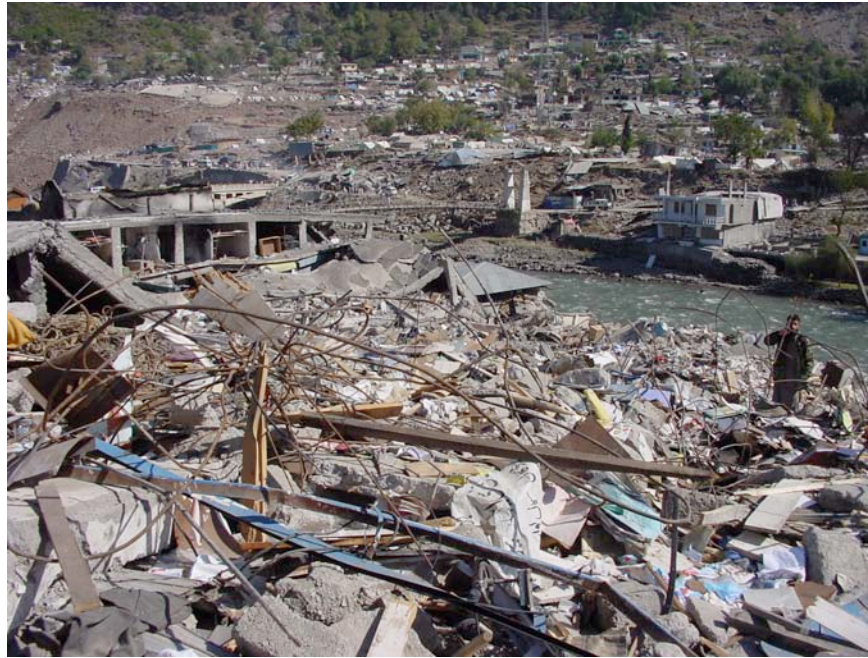
From the areas visited, maximum damages were observed in the city of Balakot. The ground motion seems to be have been very severe in and around Balakot. Ground rupture has been observed in several areas within the city and in the vicinity on mountain slopes, roads and pavements etc. Also in some areas a slump in the ground along the fracturing was observed.

Devastation at Balakot

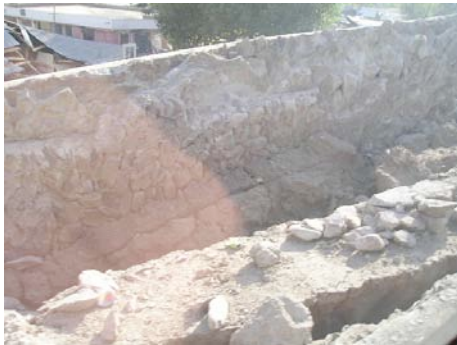
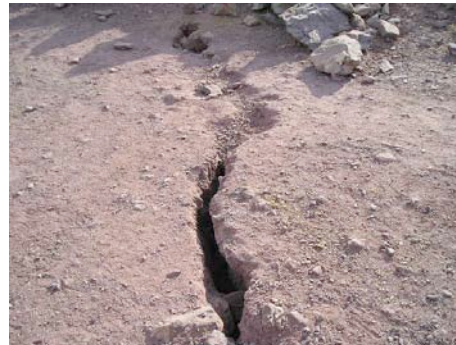
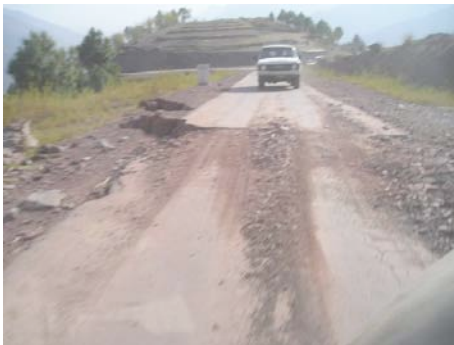
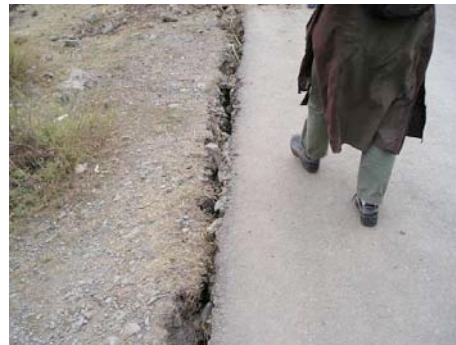
The maximum size of the observed openings were about 15-20 cm in width and few meters in length in some places while in some places width of the openings was limited to few centimeters. It can be inferred that Balakot was surely falling within the rupture zone; therefore the intensity of the earthquake impact was very high within the city area. Heavy destruction in the city was mainly due to the high intensity of the earthquake and the buildings and other structures could not withstand the ground acceleration created by the earthquake.

Fissures and openings caused by the earthquake

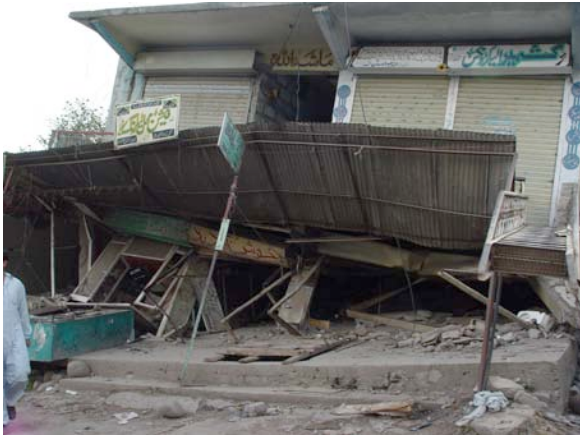
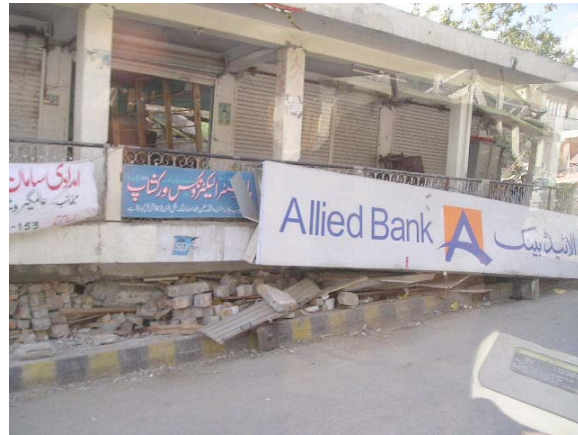
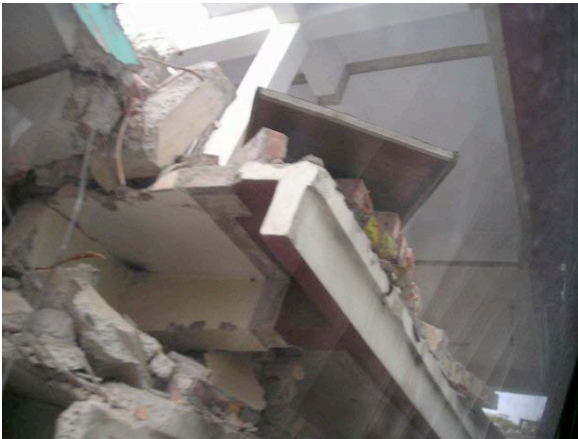
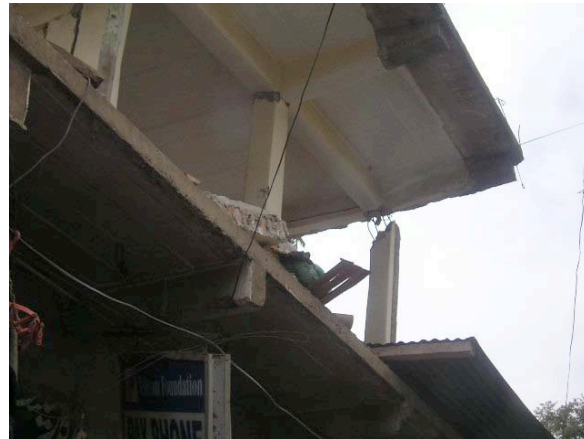
Structural failures

In some buildings structural defects have been noticed which are related to weak joints, poor workmanship and design shortcomings. This has helped to prove one of the misconceptions that the concrete buildings are stronger. As a general practice most of the buildings in such remote areas are constructed using the general construction practices, without engineering advise and supervision and therefore cannot be considered as engineered buildings. No building codes have been applied strictly, in terms of quality control, as is the case in many developing countries One general practice is incremental expansion of buildings depending on the availability of funding and people tend to leave reinforcement bars unprotected when they construct the ground floor with the expectation of

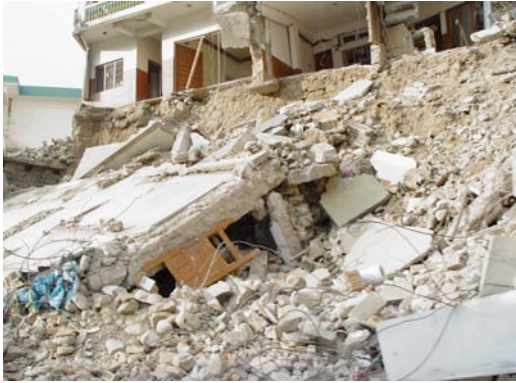
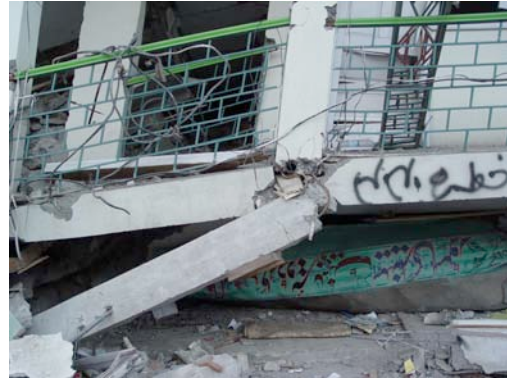
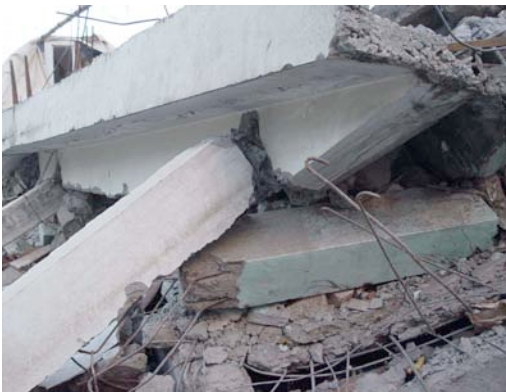
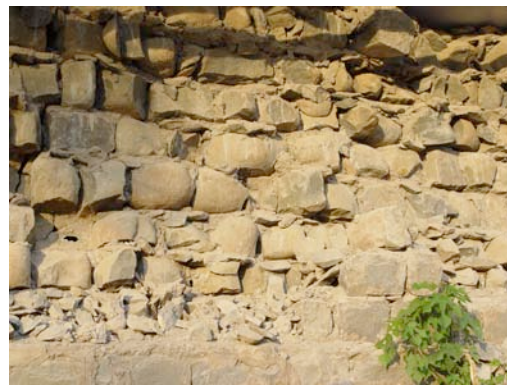
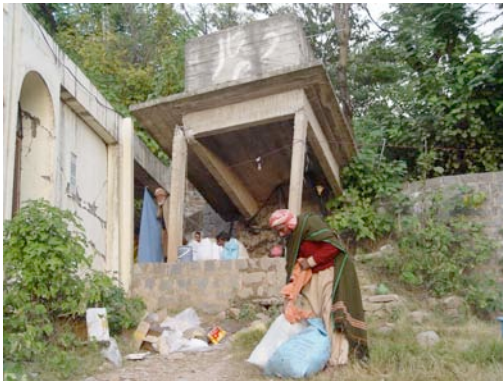
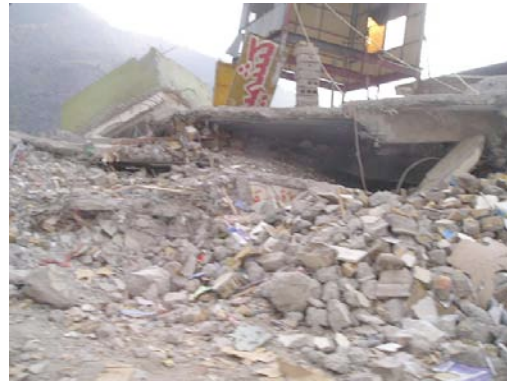
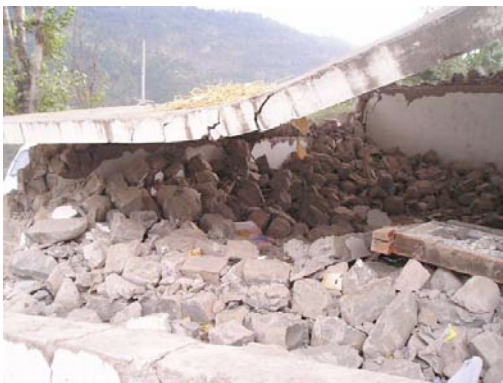
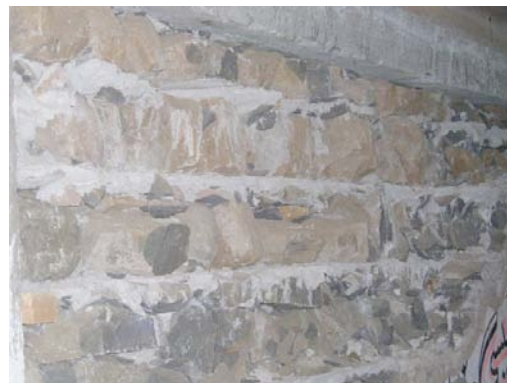
**Causes of failure
(Weaker joints, structural failures, poor workmanship etc.)**

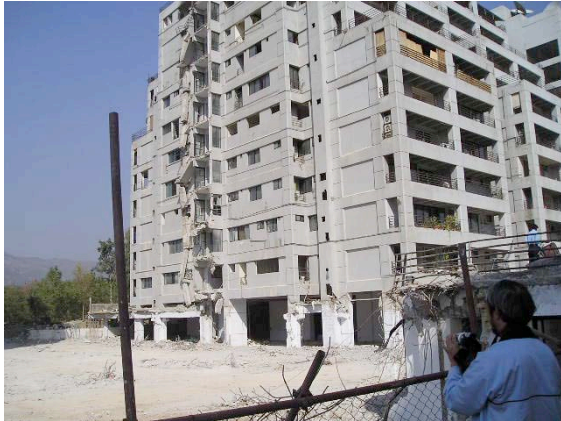
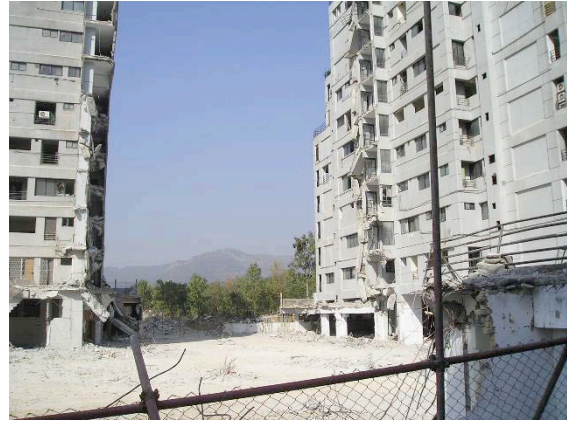
The team also inspected one of the building sites in Islamabad where one multi-storied building collapsed totally. At the time of inspection the damaged areas had been cleaned up but the onlookers who had seen the building collapse told that the ground vibration continued for a considerable time (nearly about 1 to 2 minutes) and the collapsed building along with other neighbouring buildings started swinging and later gave away while other buildings remained intact. It is pre-mature to make a decision on the failure mechanism but there should be a through investigation into the event rather than reaching conclusions through assumptions.

Multi-storied building collapse

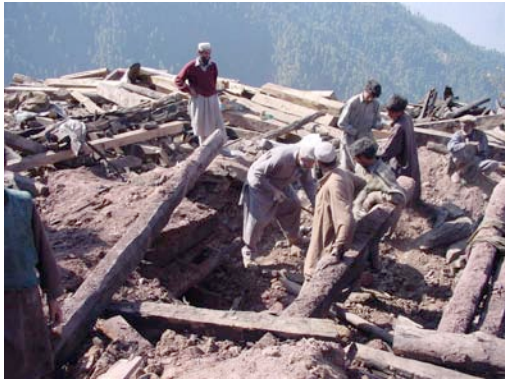
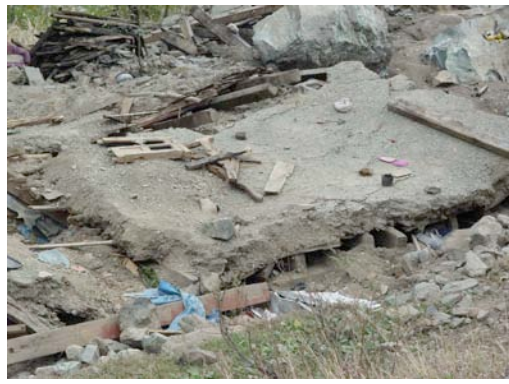
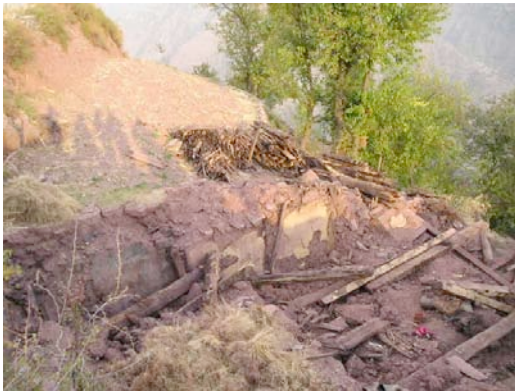
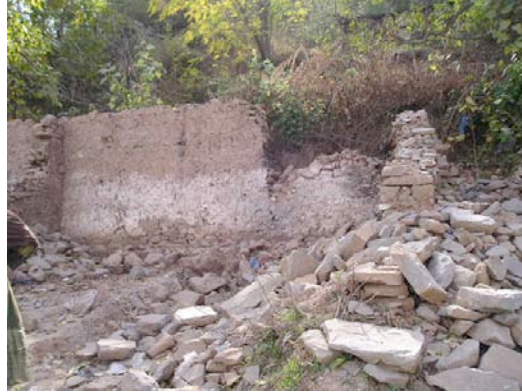
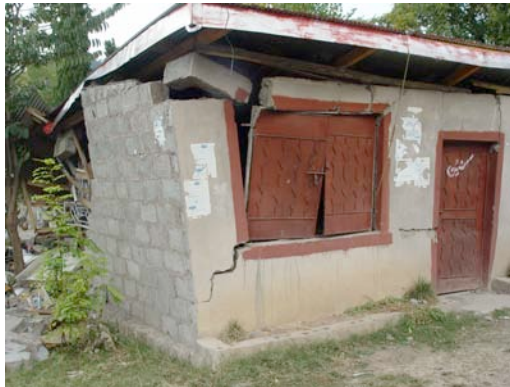
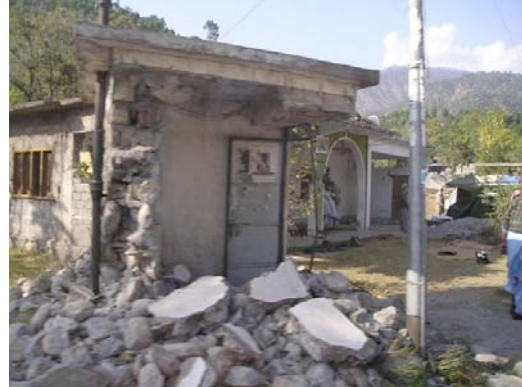
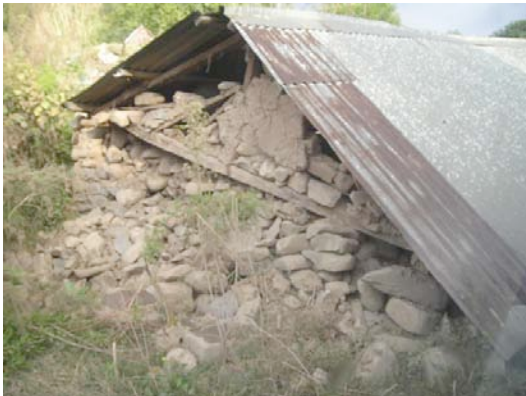
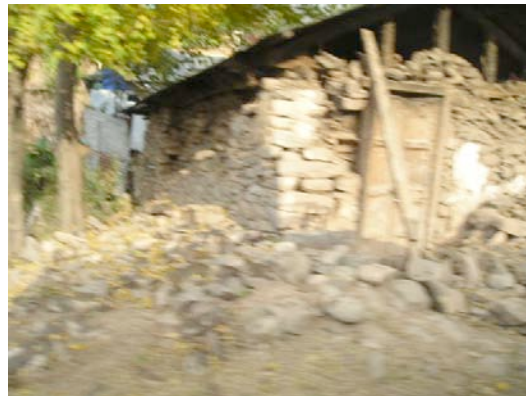
Majority of the dwelling houses in the rural areas are built using traditional practices. The walls are either stone masonry with clay mortar or are stone packed. In certain cases the walls are adobe construction with clay mortar. The roof is constructed using a single or few layers of timber, covered with grass and clay. This gives better insulation and protects from rain and snow during winter. Some people had misconception that the buildings collapsed due to heavy roof slab but actually they have collapsed under the impact of ground acceleration created by earthquake on the weak walls. In addition to foundation material and walls, configuration of the buildings, which is usually rectangular in shape, and the building direction also play a role. According to the findings one or more factors mentioned above have contributed to collapse of such buildings.

Destruction to rural houses

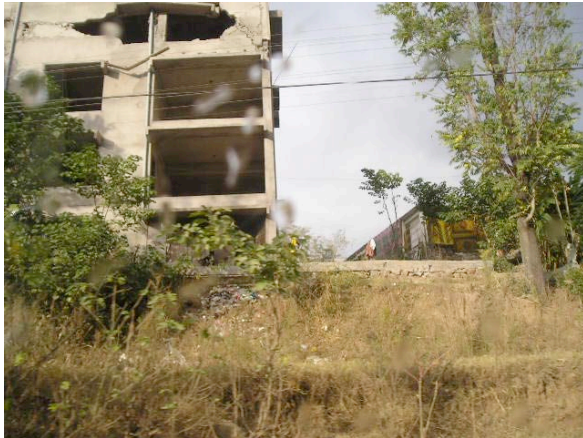
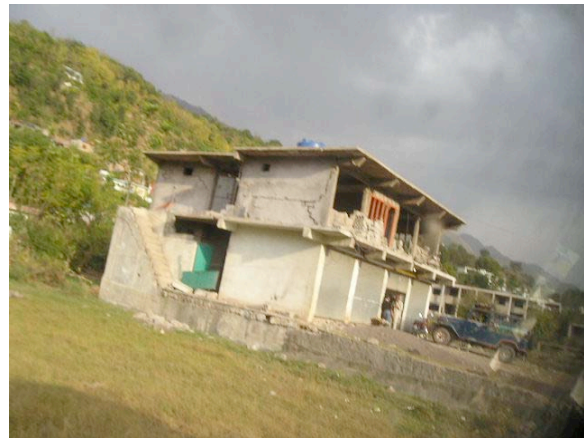
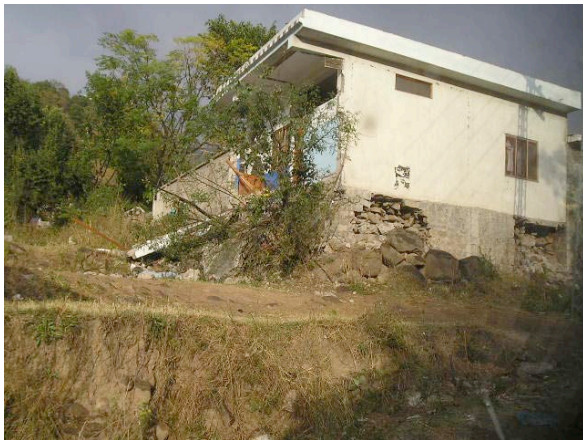
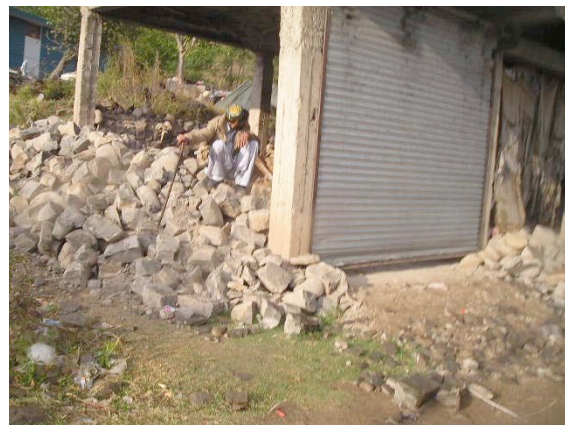
Majority of houses in urban areas (Balakot, Mansehra, Bagh etc.) are modern buildings like in any other developing country in South Asia. The team observed some of such structures, dwelling houses that were, mostly single story buildings (mostly light frame structure, light wall structures with columns and concrete slab) and some multi-storied buildings that had been partially or totally destroyed. It was found that general defects seen in the commercial buildings were also common to these types of buildings. The cement block buildings with weaker mortar layer suffered most destruction.

Destruction to the modern dwelling houses

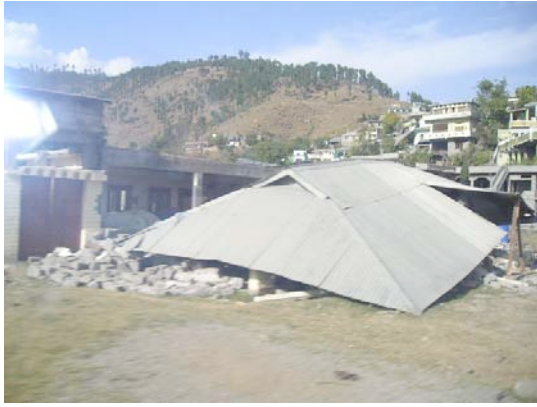
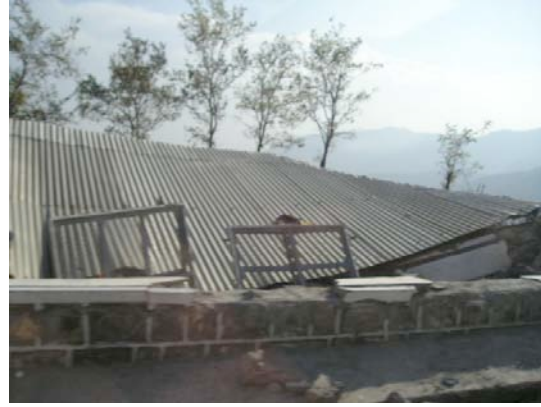
Therefore, vulnerability of the constructed houses is caused due to weak walls, overall workmanship, poor design as well as structural defects. It is generally perceived by communities that light roof might be better in terms of saving lives, but if walls are not strong enough then even light roof houses will become death traps.

Light roof does not save lives

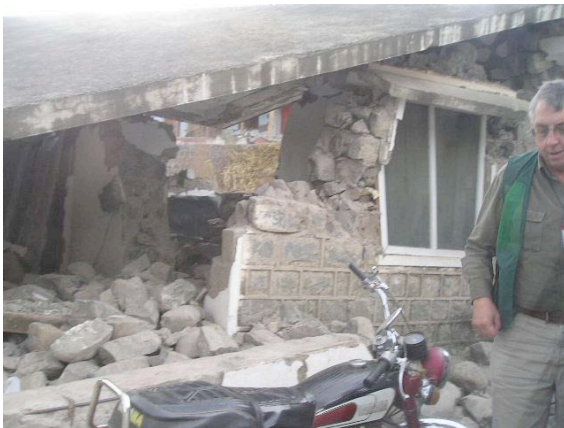
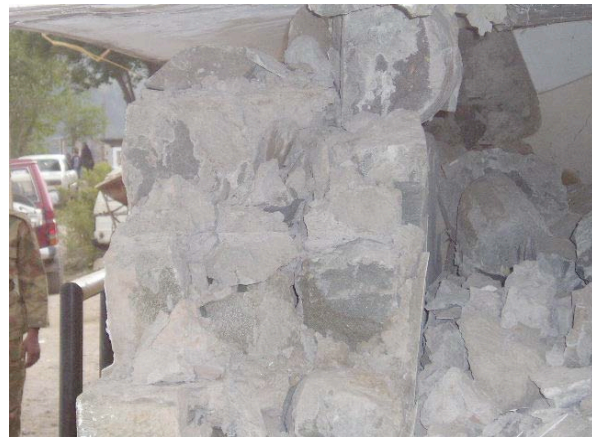
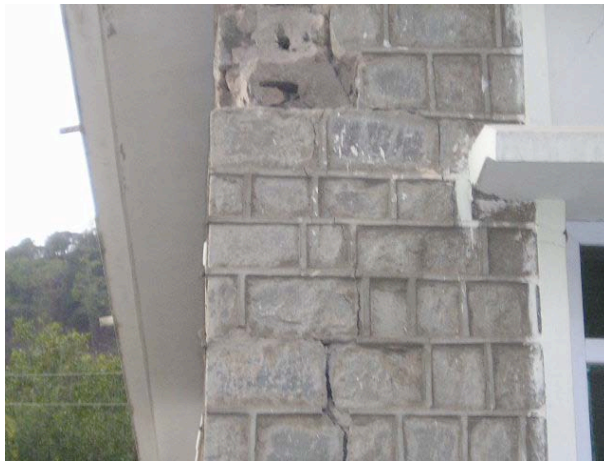
The team could not inspect many government buildings. Comments made herein should not be taken as the general reason behind the collapse of such buildings. The buildings might not have been designed to withstand such a high intensity earthquake and that might be the main reason behind their collapse. As per the observations made on a few buildings, vulnerability has been caused due to poor technology used (workmanship and construction material). The government buildings are usually designed and supervised by engineers and have been constructed according to the building codes. The general practice followed by government institutions is to conduct an investigation on the failure pattern, which should be taken as an opportunity for review of building codes. The quality may have suffered also due to the usage of river stones as construction material. The general practice in Bagh, as observed, is to use splitted stones, obtained from river bed, as construction material but because of their rounded surface they provide weaker bond when used with weak cement mortar. These tend to be subject to shear failures easily. The interlocking may provide additional strength, when rough and irregular surfaces are placed against each other during construction, but the methodology adopted in construction in Bagh is not the best option to acquire required strength to withstand very strong earthquake ground accelerations. It would be better to review such traditional practices in future.

Destruction to the government buildings

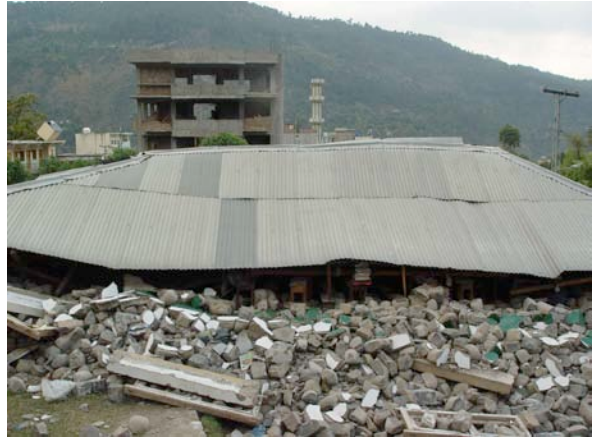
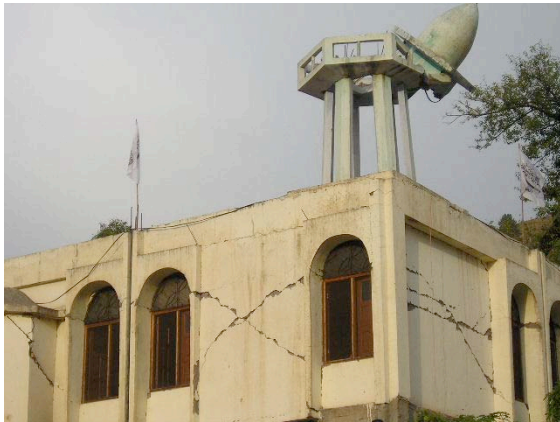
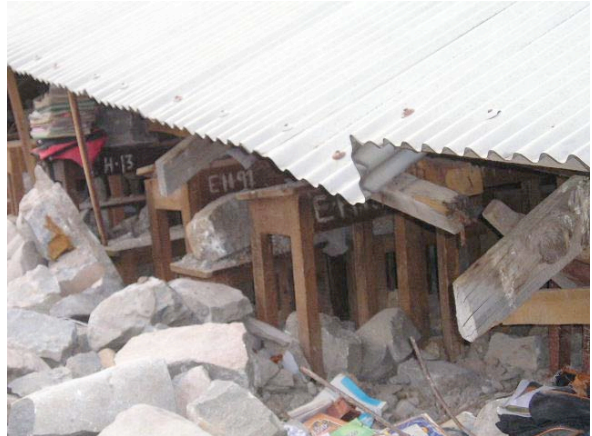
One of the lessons that can be learned from the heavy damages to service buildings is the need for special design codes and practices for construction of such critical facilities. Though these buildings have to be constructed quickly but the decision on adoption of special construction codes for such buildings have to be made as a priority requirement before the commencement of reconstruction programs.

Destruction caused to School buildings and Mosques

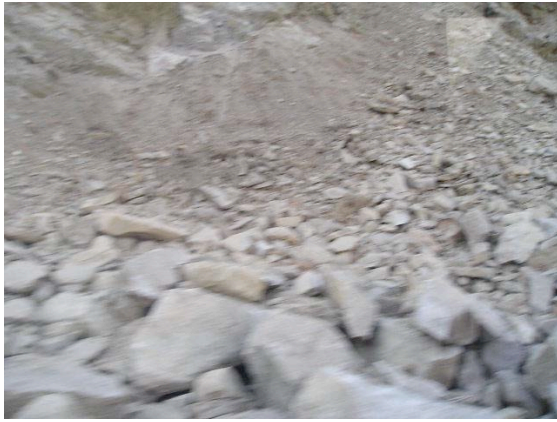
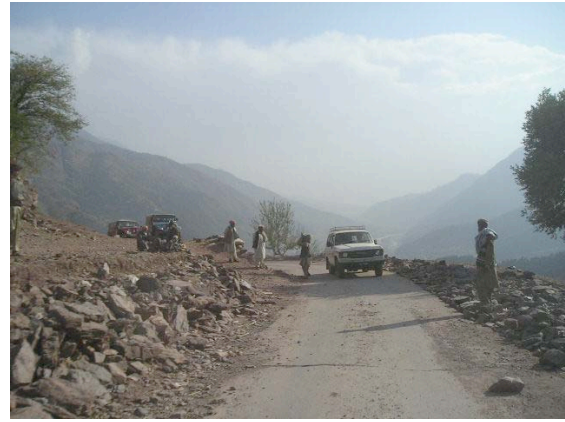
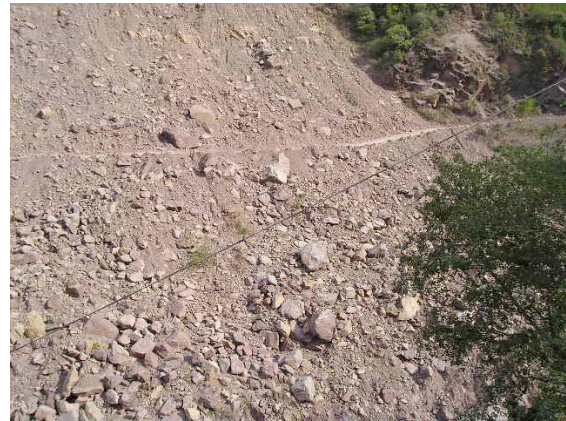
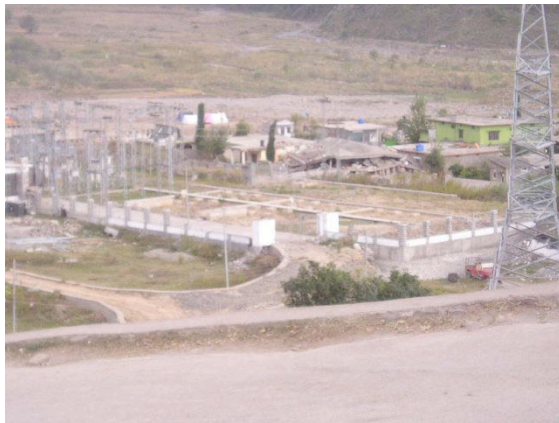
The infrastructure, such as roads and bridges, and lifeline facilities, such as electrical supply lines, water supply lines etc. also suffered heavy damages. The road network was paralyzed due to large-scale landslides and slope destabilization due to the high ground motion. Some of the bridges even suffered minor displacements, in Balakot and Bagh. The roads have been cleaned up as of now but after the winters and during the monsoon season the mass movement can get activated again. The electrical supply was disrupted due to damage to supply lines, transformers etc. Also the water supply was disrupted due to the damage of supply lines.

Photographs of destroyed infrastructure facilities

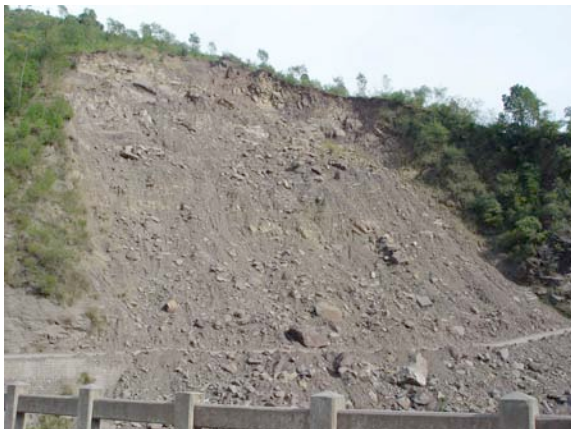
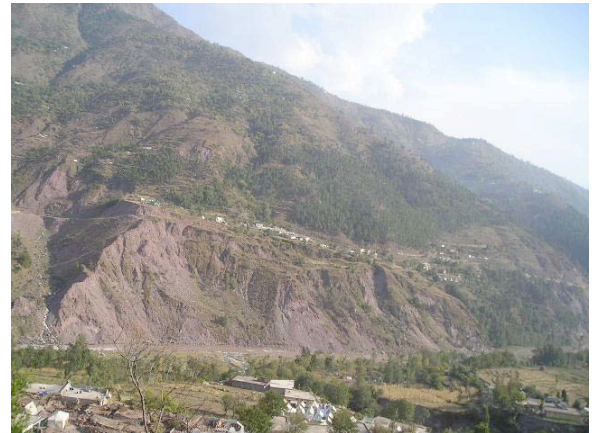
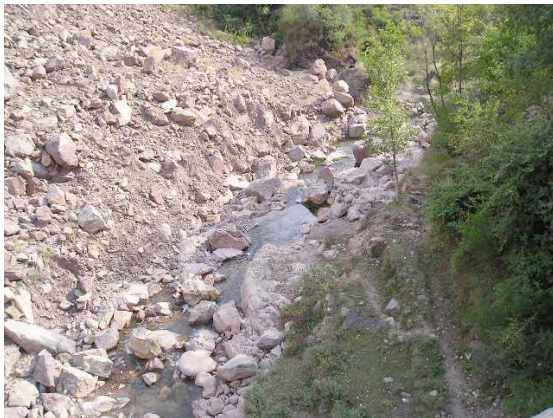
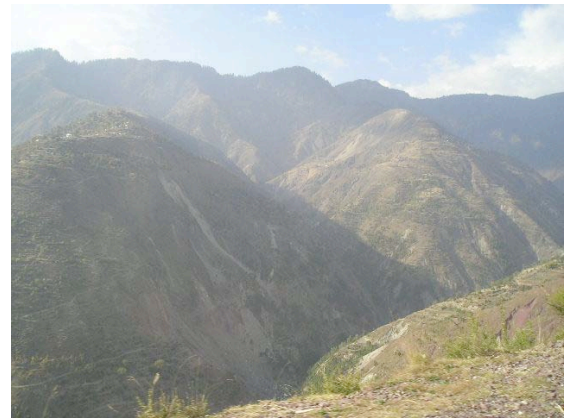
The impact to environmental resources and bio-diversity by this earthquake are also considerable. Many big landslides occurred in Balakot area. Many roads, in Balakot as well as in Kashmir, were blocked by debris, which will continue to create similar problems during as well as after monsoon. River network is also blocked by debris flow, causing contamination of river water.

Landslides caused by the earthquake

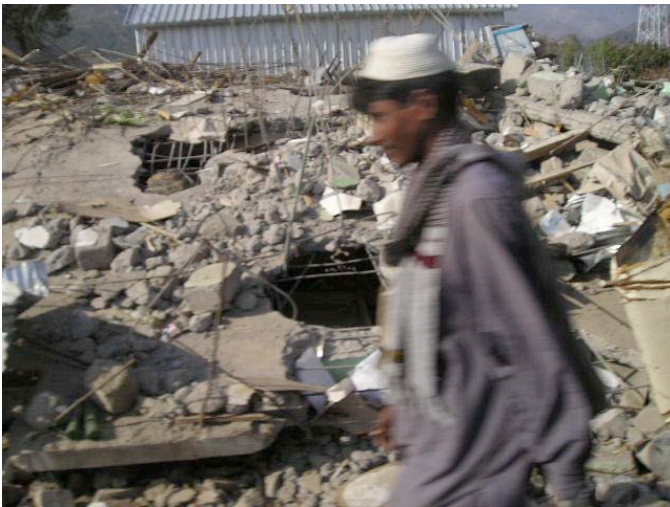
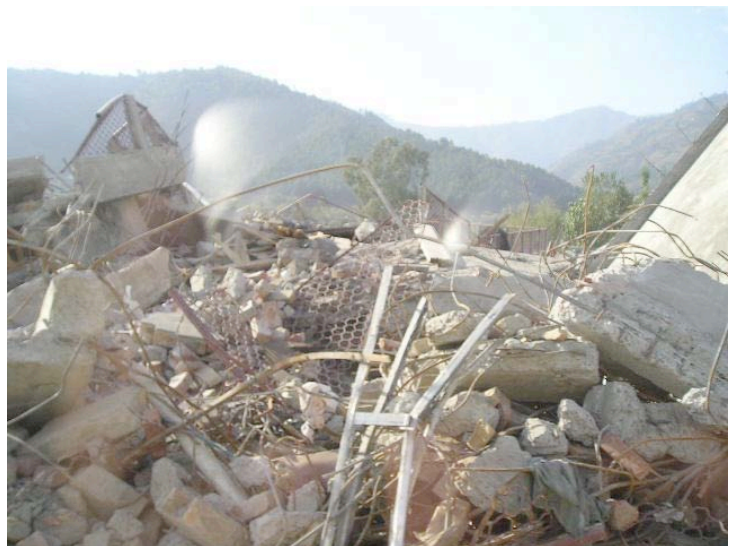
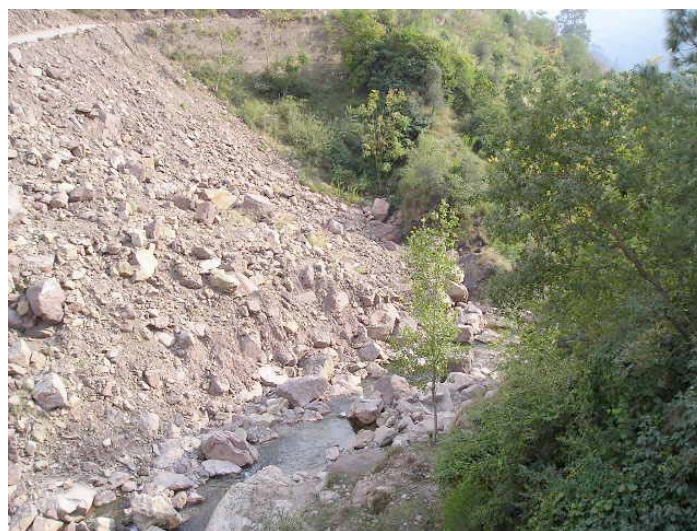
In most of other areas the disaster lead to the environment pollution. The cleaning operations were successful in cleaning up of roads and transportation network, but the cities affected, which had become a pile of debris, cleaning up activities have yet to start. Since most of the dead bodies are still buried under the rubble, it will be difficult to commence the cleaning up operations in some of the cities. On the other hand, some of the commercial operations have started in the buildings, which were partially destroyed, for example in Bagh and Mansehra to satisfy the customers before the festival season.

Rubble and destructions

It would be better to undertake measures to recycle the material found everywhere amongst debris, rather than further polluting the rivers and lower areas through filling of cleared debris. People should also be educated and made aware about undertaking environmentally friendly practices during cleaning up operations.

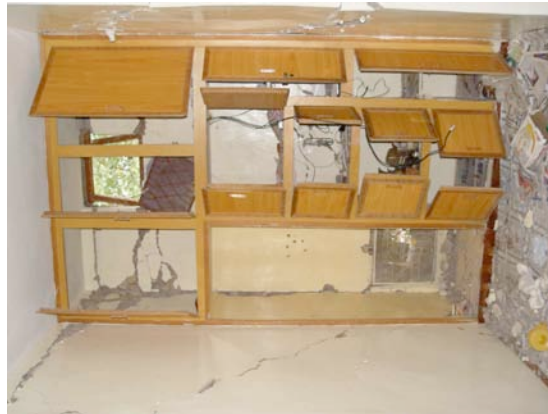
Non-Structural defects

- Determination of the status of affected buildings to be carried out by a qualified set of professionals and damage and loss estimation should be carried out with the status report prepared by them. An inventory and certification of status and estimation of damages should be done as soon as possible and it should be viewed as one of the priority subjects under the recovery program. There are buildings with minor as well as smaller structural damages, which can be easily retrofitted without demolition. But as common people will not have correct understanding about which buildings should be demolished which should be repaired, the inspection teams should be able to provide such advise during the loss estimation process.
