## **Landslide Risk and Remediation Techniques for Road Construction**

*Dr. P K Nanda*

*Central Road Research Institute, Delhi-Mathura Road, New Delhi – 110 020*

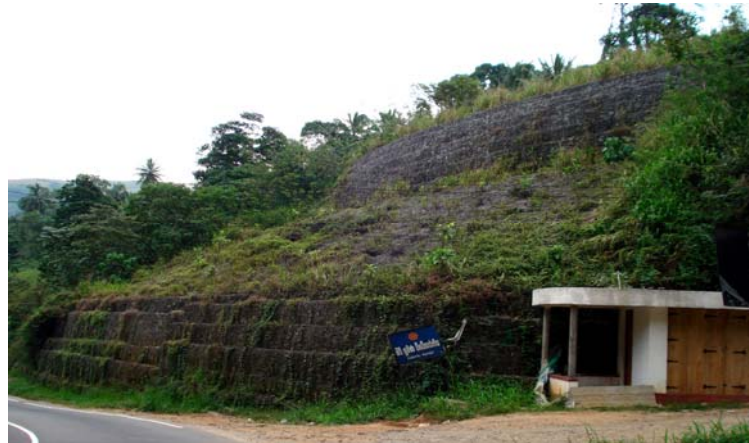
Since the land slide prone area is about 17m high, a retaining wall was constructed using gabion. For the above construction a combination of Terra mesh, gabion mattresses and gabions were used.

**Gabion Construction at Balakaduwa**

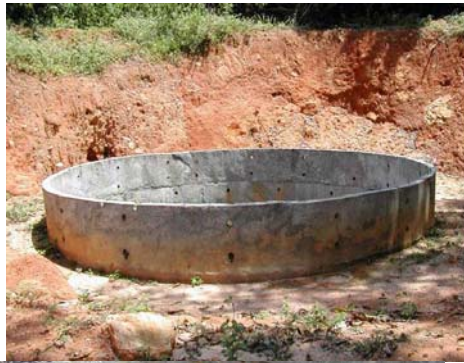
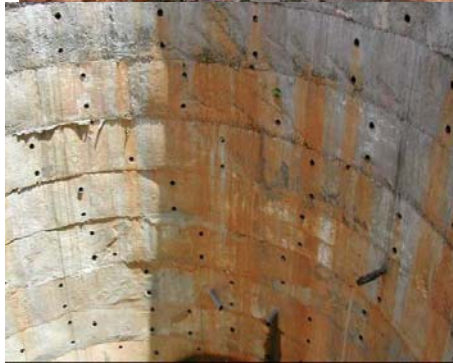
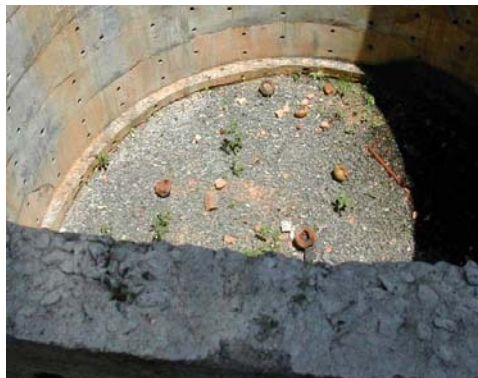
- a. A drainage well was constructed at location of borehole where artesian pressure was observed.
- b. 03 No. of horizontal drains were constructed to lower the ground water table below the road level.

Drainage well at Marangahawela landslide on Colombo-Ratnapura-Wellawaya-Batticaloa Road on 170<sup>th</sup> km

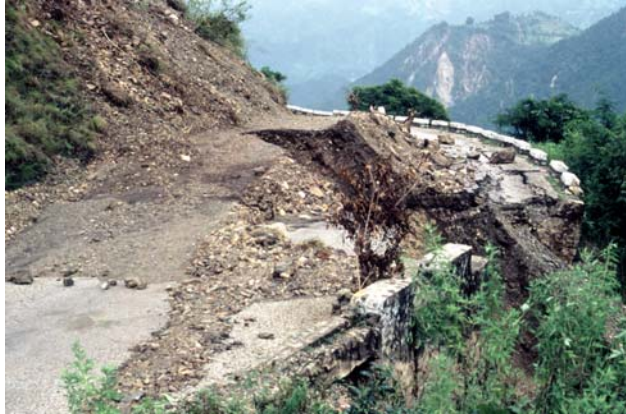
(Failure of valley  
side concrete  
masonry retaining  
wall due to poor  
foundations)

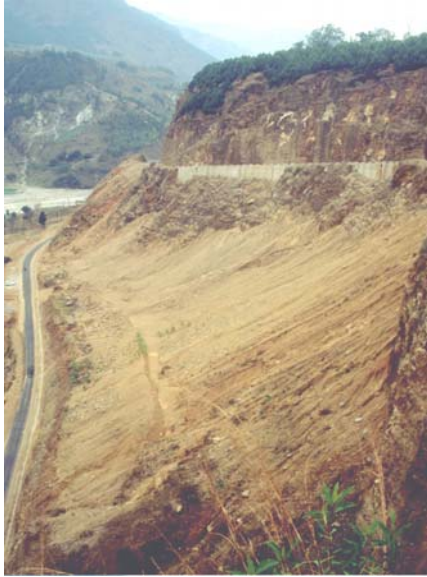
(Baglung loop before Bio-engg in 1994)

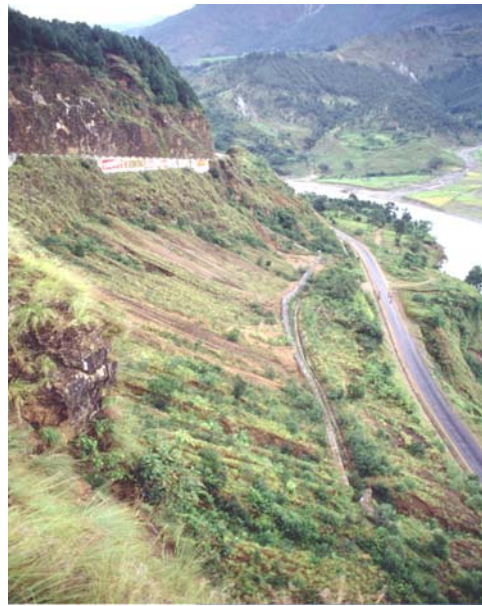
(Baglung loop after Bio-engg in 1997)

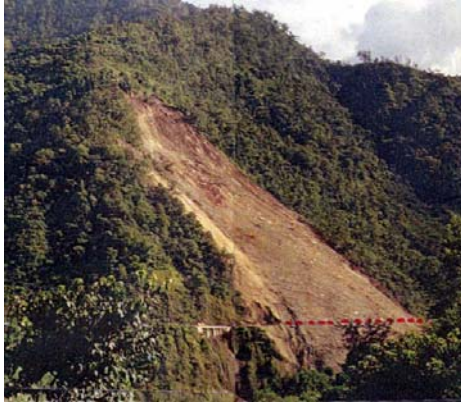
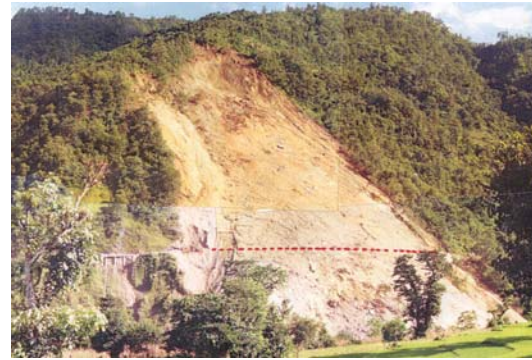
(Failure on August 21, 2000)

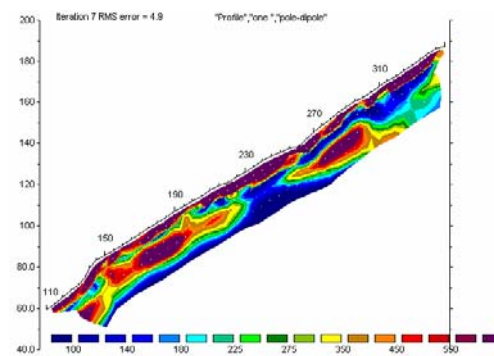
(Resistivity Tomograms along the center line of the slide)

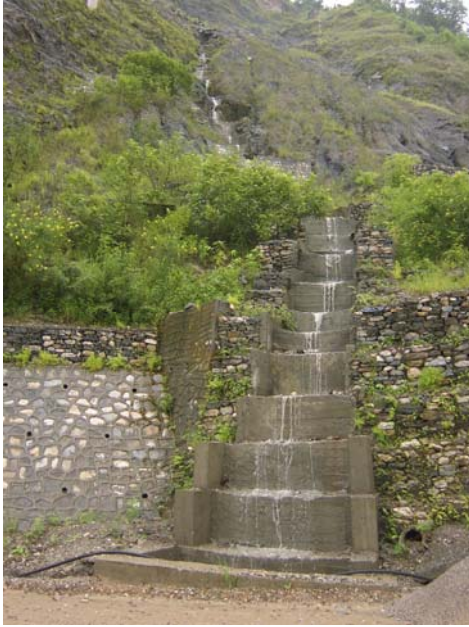
Water management did appear to be the main problem, so, uncontrolled flow of run off from the crown which is about 350 meters high (vertically) from the road level, diverted into the three naturally created gullies. Catch drains were provided beyond the crown area of the slide to prevent the water gushing down into the landslide. When the water is diverted into the natural gully, it has a severe damaging effect and it is important to dissipate the energy to reduce its damaging effect, so, series of concrete and gabion check dams, cascade drains etc. were designed and constructed along these gullies to dissipate run off energy. Steeply inclined pipe culverts at each of these gullies were provided to safely discharge water and debris under the road preventing blocking of the road by these flowing debris.

(Water management)

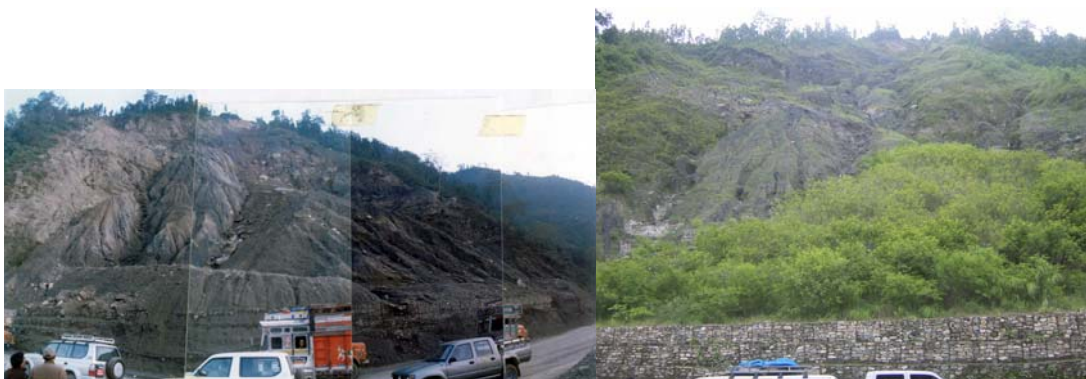
(Slope in 2003)

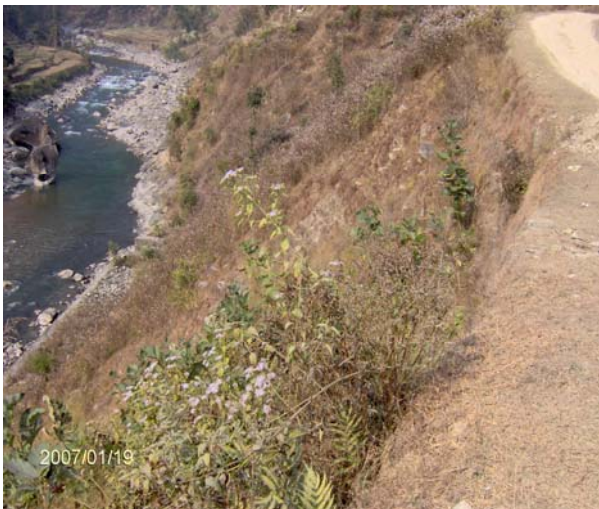
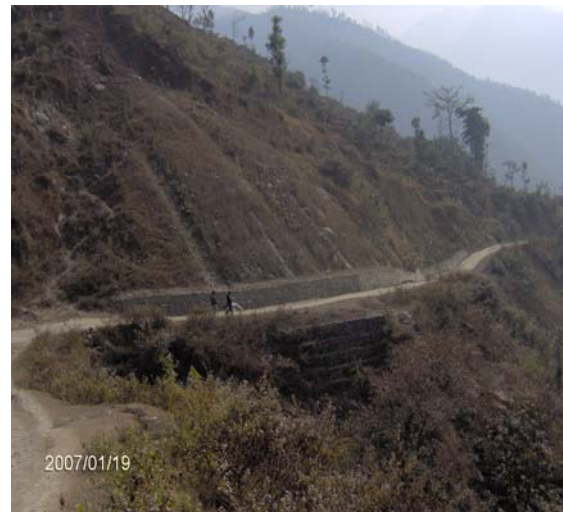
The following consists of the use of catch drain, dry stone pitching, Plantation, vegetation, stone masonry toe wall and Gabion retaining wall at the Landslide protection work in Balephy-Jalabire Road shows that only Bio -Engineering work does not fulfill the requirements to retain the slide.

#### **Slide control with dry drain, dry wall, Gabion wall, vegetation and toe wall**

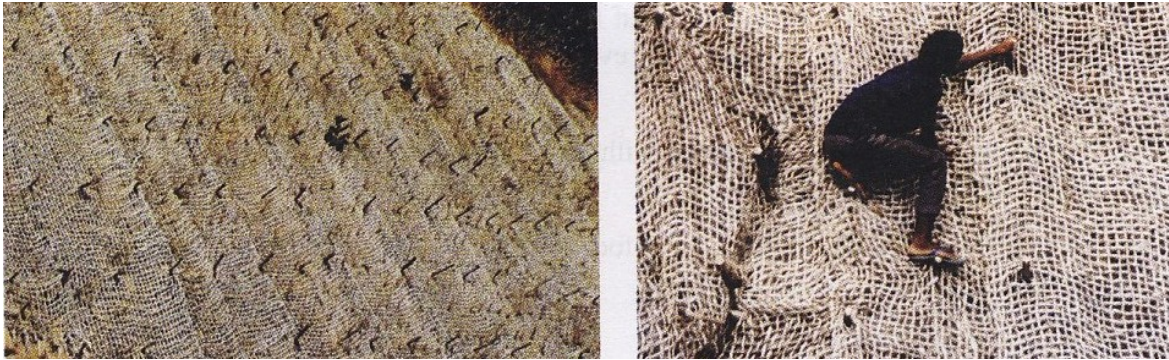
Jute Netting: Dressing the slope, grass seedling or planting, mulching before jute netting. Jute net is stretched by live or dry pegs.

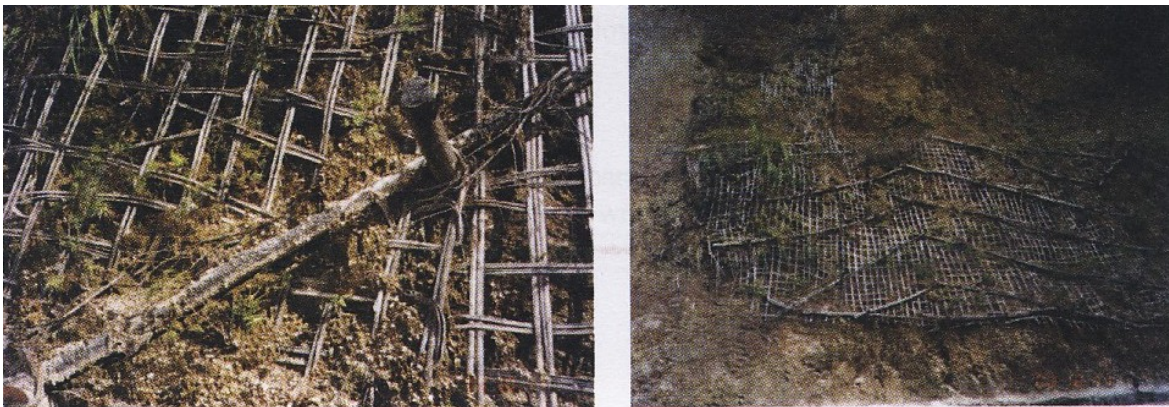
Bamboo Netting: This can be the alternative of coir netting. the mesh size depends on the slope and soil type.

Bamboo fencing: It is used for soil retaining works.

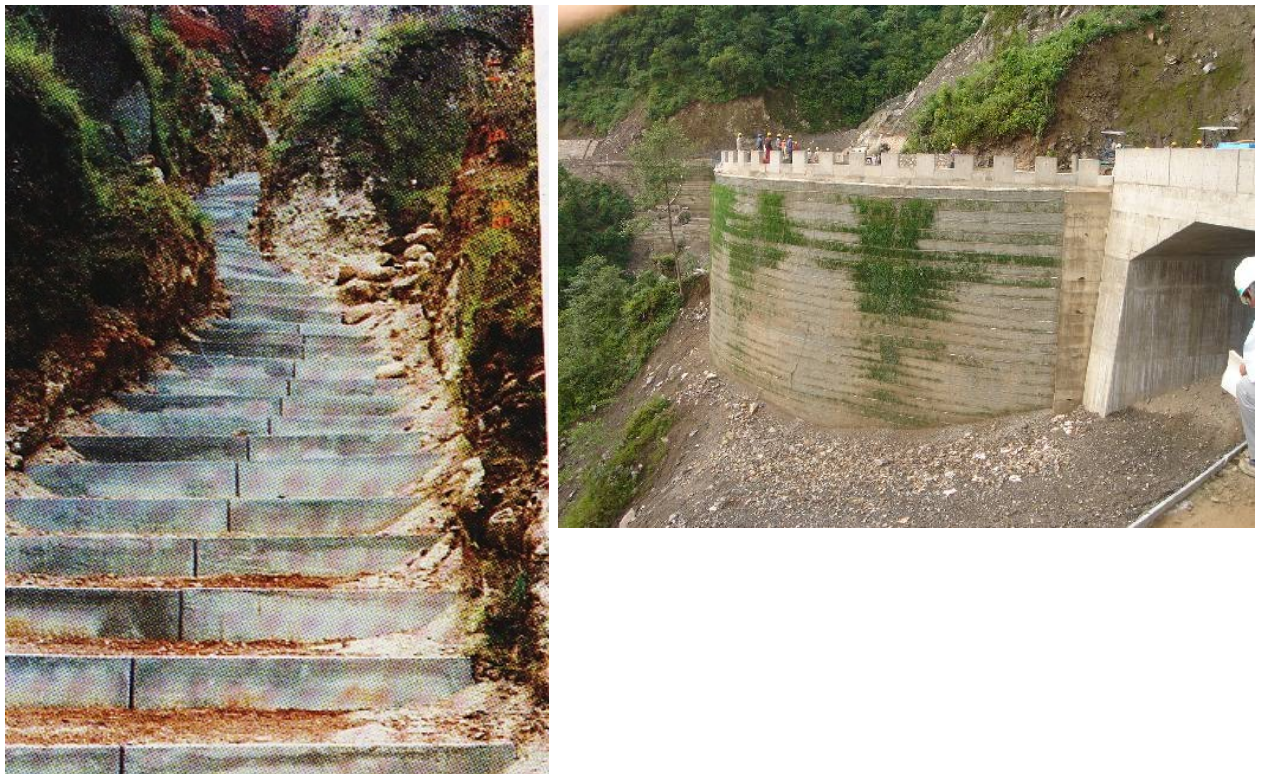
Use of PNC blocks for the Gully protection and Gabion Wall with vegetative layers for landslide control.

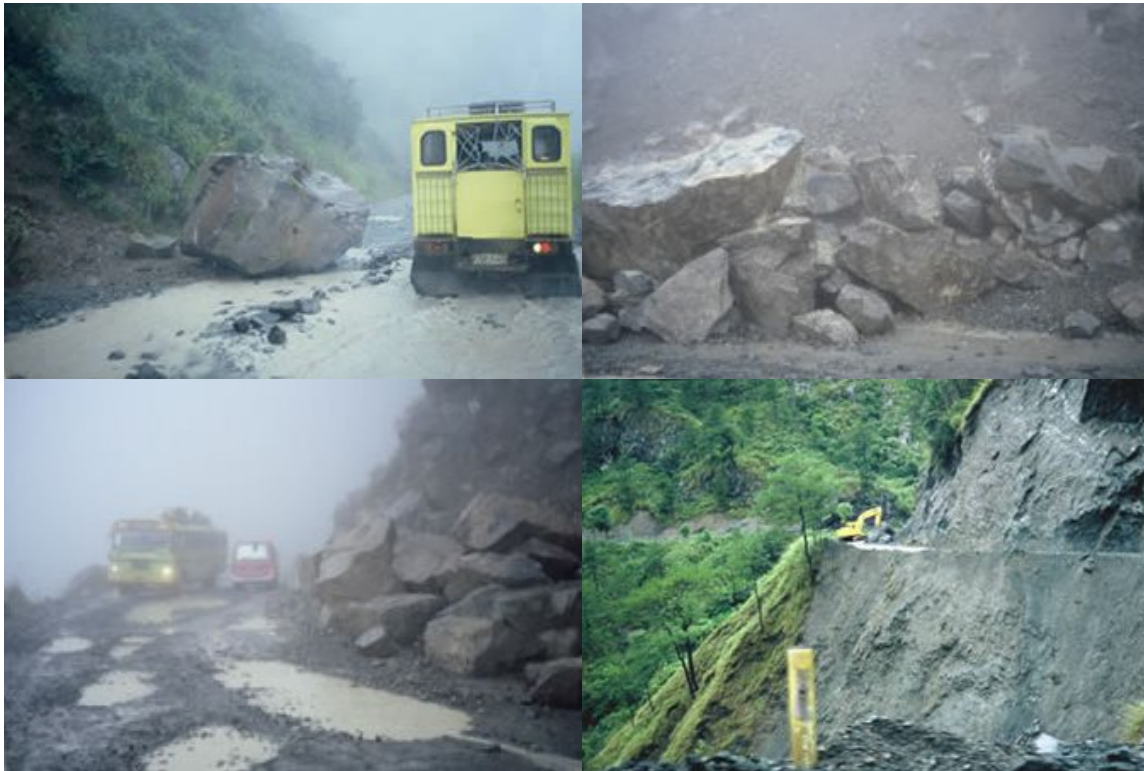
**Fig. 7** Rockslides along Helsema Highway, northern Philippines.

slope failures are not as well established. However, engineering countermeasures for reducing landslide risk are observable; these generally involve the use of slope stabilization methods such as benching, improvement of subsurface drainage, construction of retaining structures, and reinforcement of slopes. Majority of these slope stabilization measures are undertaken in connection with road construction projects. This section briefly describes the current engineering practices in the Philippines for stabilizing and/or protecting precarious slopes (Fig. 7).

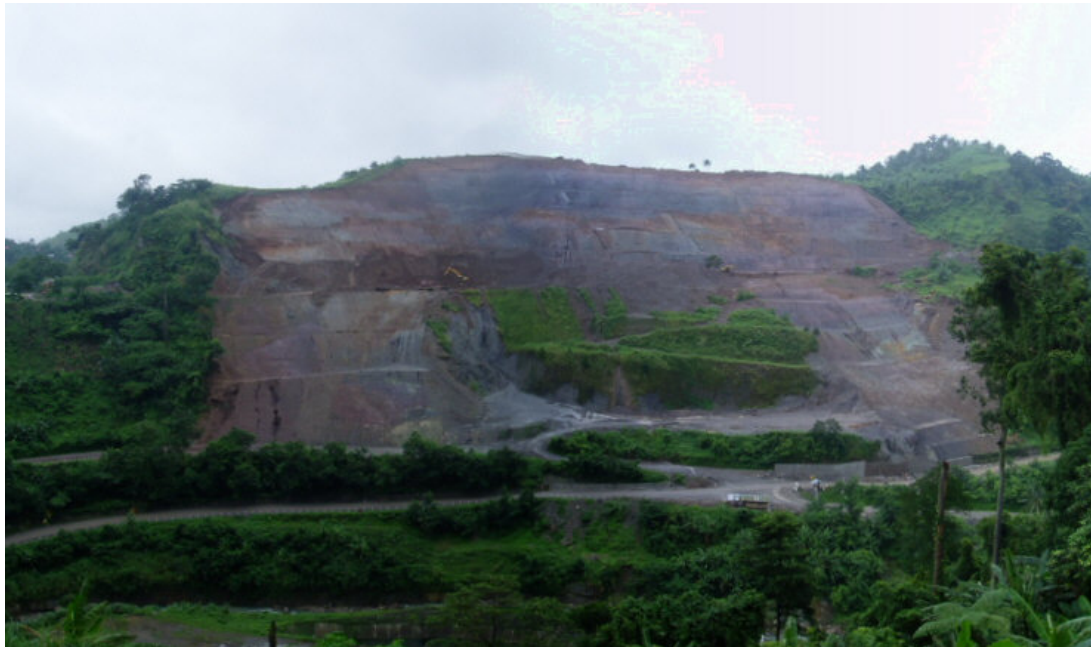
**Fig. 8** Benching of slopes in Tongonan, Leyte.

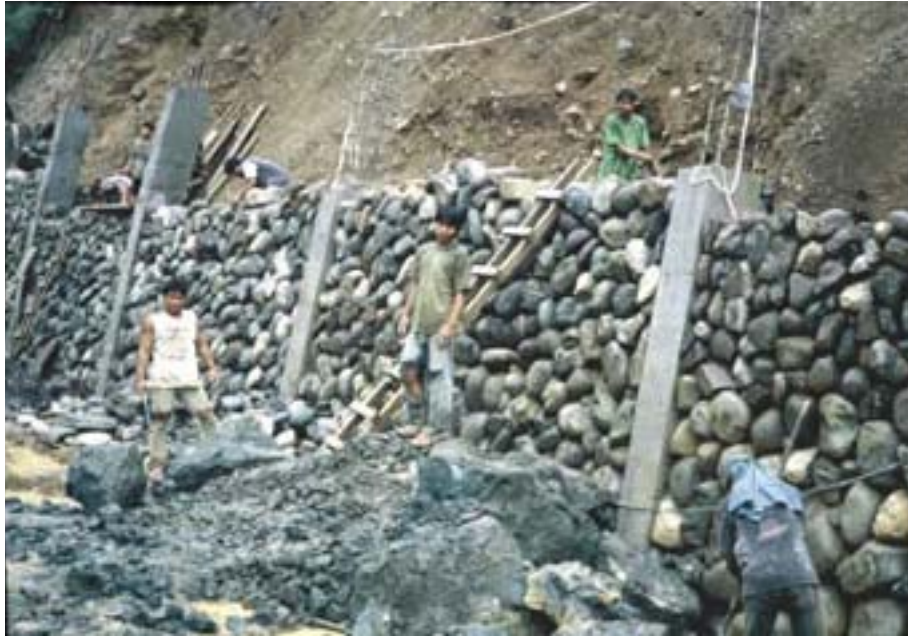
**Fig. 10** Grouted Riprap walls along Halsema Highway, northern Philippines.

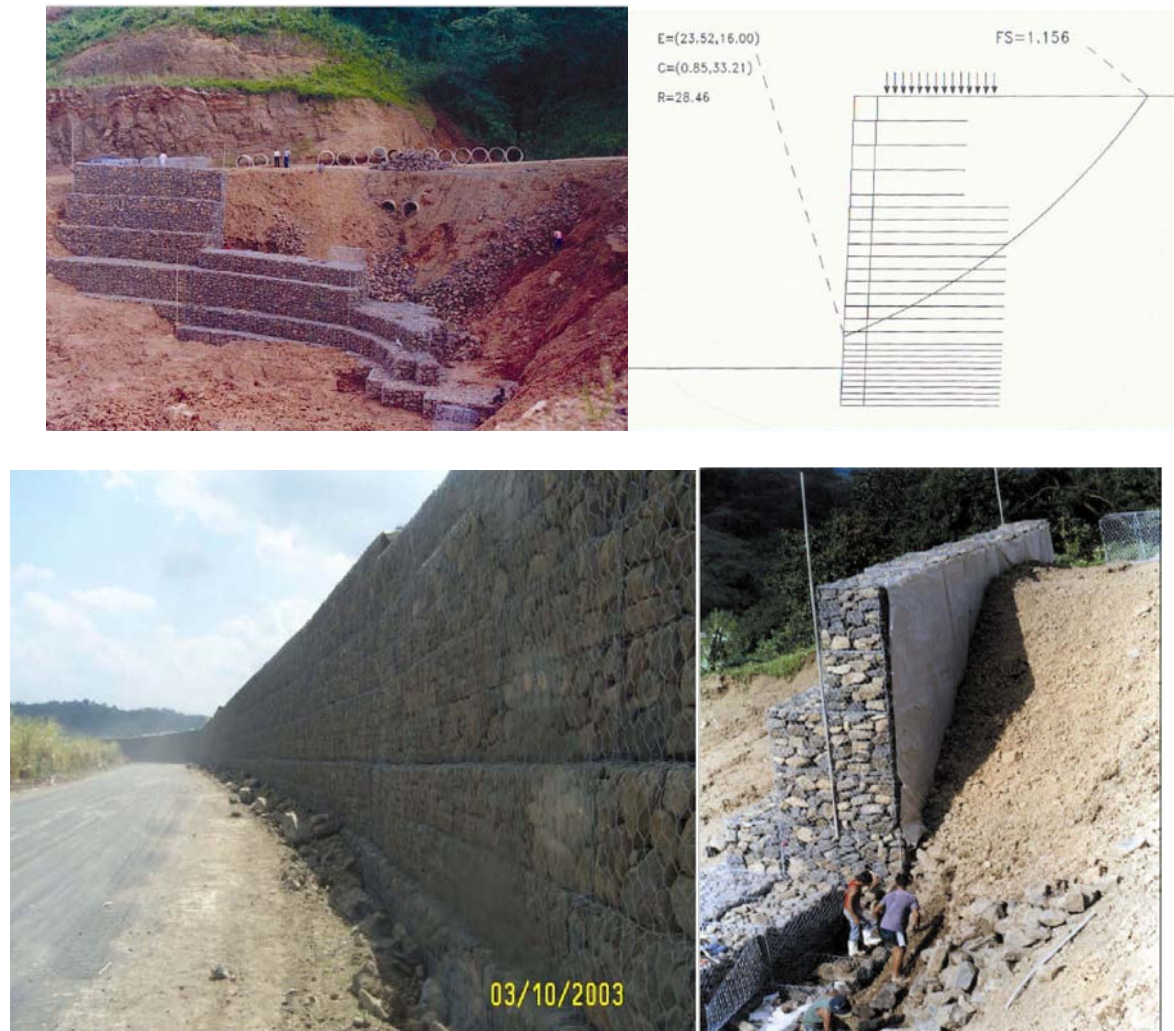
Fig.11 Applications of Gabion Walls in the Philippines.

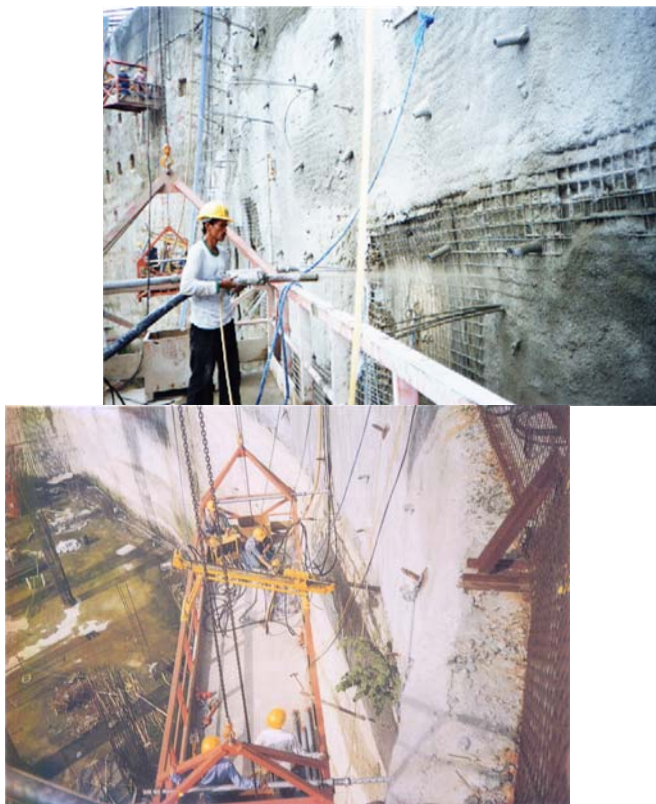
**Fig. 12** Soil nailing and rock bolting, RCBC Plaza, Makati City, Metro Manila.

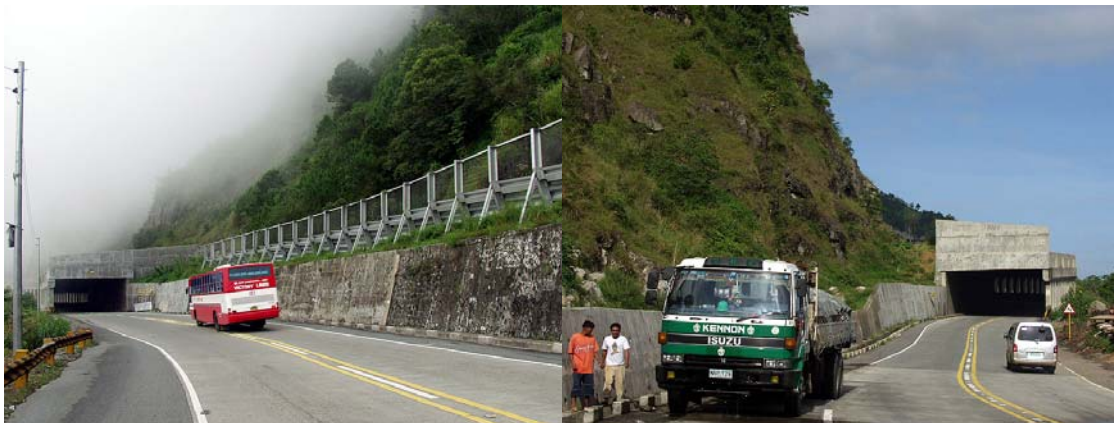
**Fig. 13** Rockslide shelter and barrier along the highway leading to Baguio City.
